JAY FISCHMAN, P.E.

RESIDENTIAL FOUNDATION INSPECTION REPORT FOR CHARLES C. WENCK

2214 HIDDEN CREEK DRIVE
KINGWOOD, TX 77339

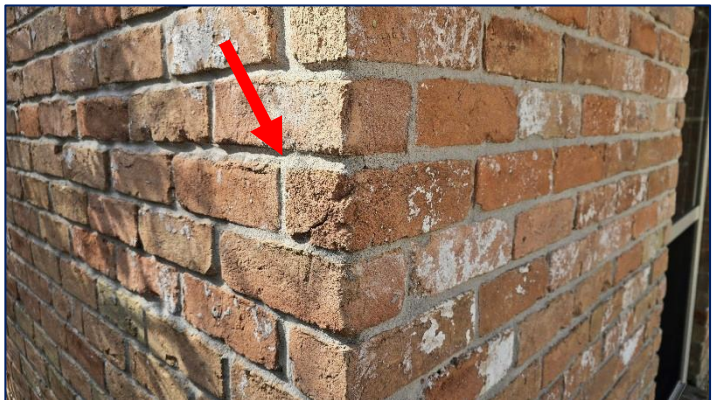
ADOBE BRICKS WITH CONCAVE MORTAR JOINTS

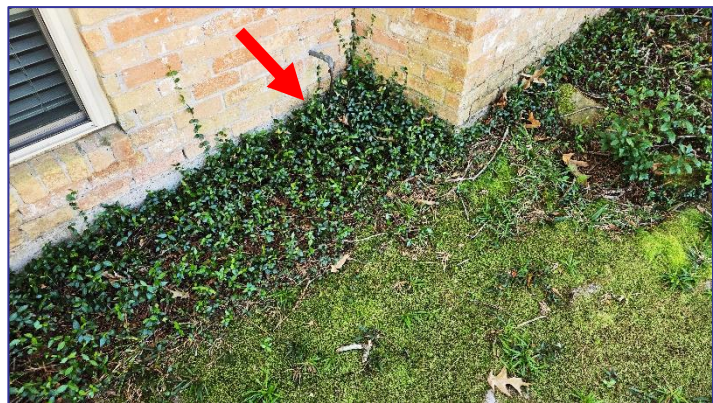
SOIL AND GROUND COVER COVERING 1ST ROW OF BRICKS

Inspection of the perimeter did reveal some visible contact of soil to bricks at a few locations. The soil should always be kept an adequate distance below the top of the foundation ensuring ample drainage away from the structure. Periodically, monitor the exterior of the structure during heavy rainfall. If water does not drain after a reasonable period of time after the rainfall, measures to provide adequate drainage away from the structure should be employed. The overall effectiveness of any underground drains was not determined. Observation of the actual drainage conditions during heavy rainfall would be necessary to determine if the existing conditions are satisfactory.

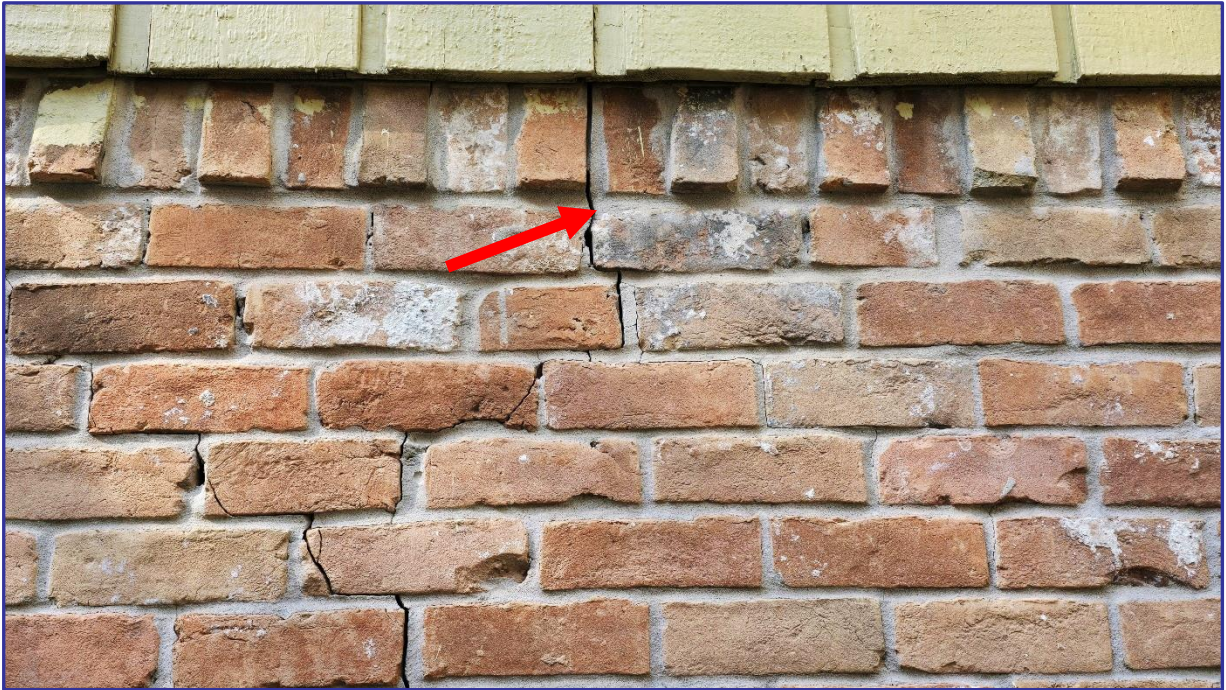
MORTAR JOINT CRACKS AT MASTER BEDROOM SIDE WALL

1. There are some mortar joint cracks at the sides of the house, particularly at the master bedroom side wall. Have an experienced mason repair these cracks to minimize water penetration to the interior and to provide a more pleasing appearance.
2. Some dark stains on the exterior bricks. Pressure wash as needed.
3. Damaged gutter at rear of the house.

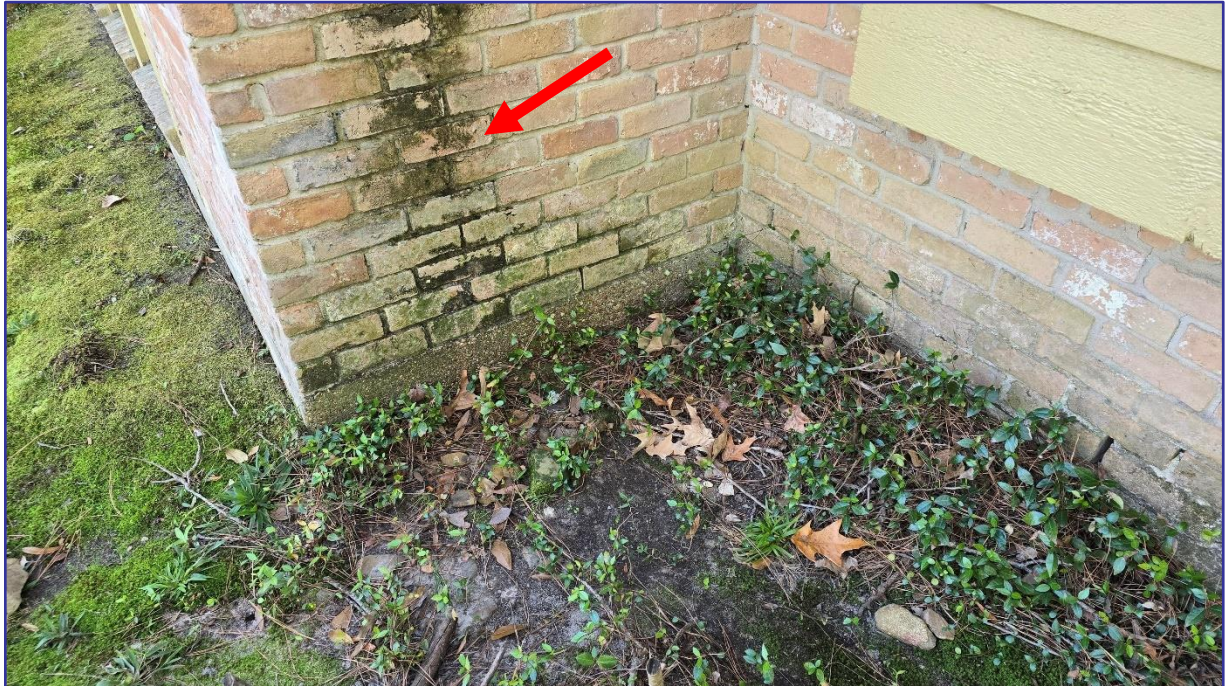
DARK STAINS ON BRICKS DUE TO CHRONIC WATER CONTACT

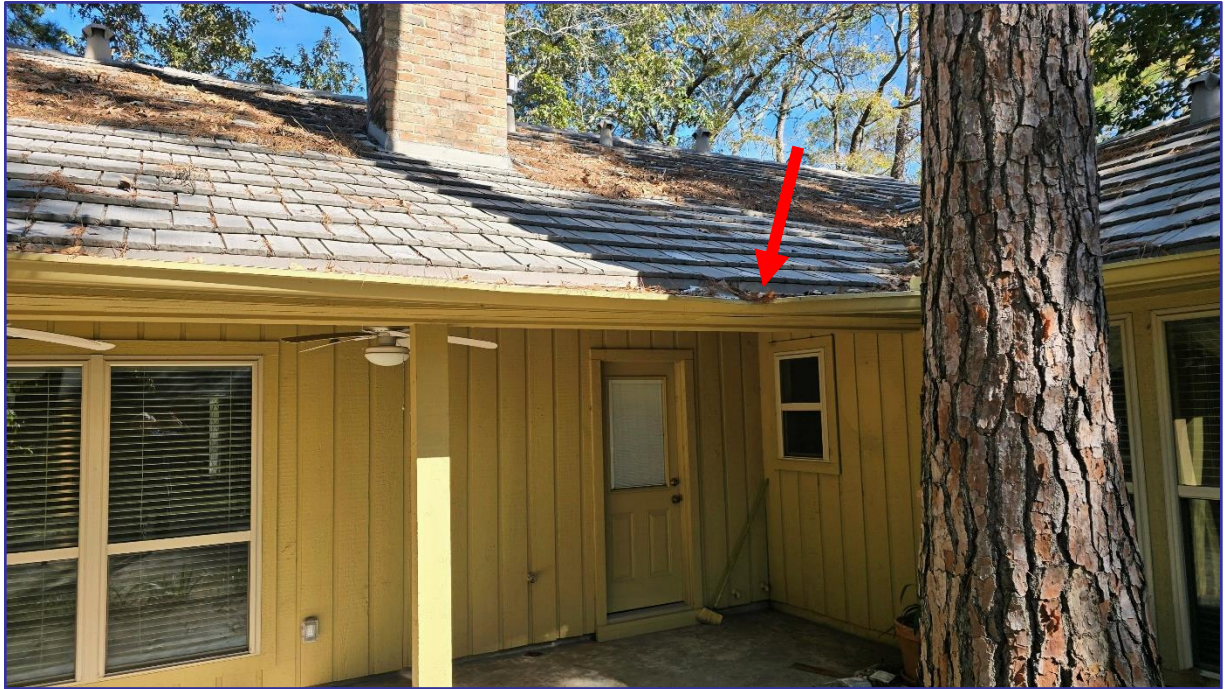
DAMAGED REAR GUTTER

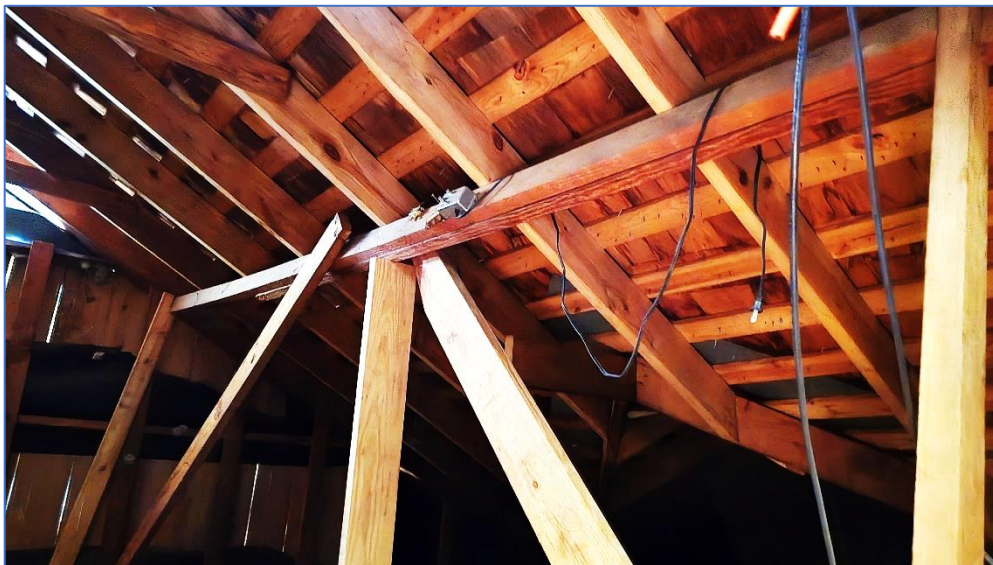
ATTIC FRAMING IN GENERALLY SATISFACTORY CONDITION

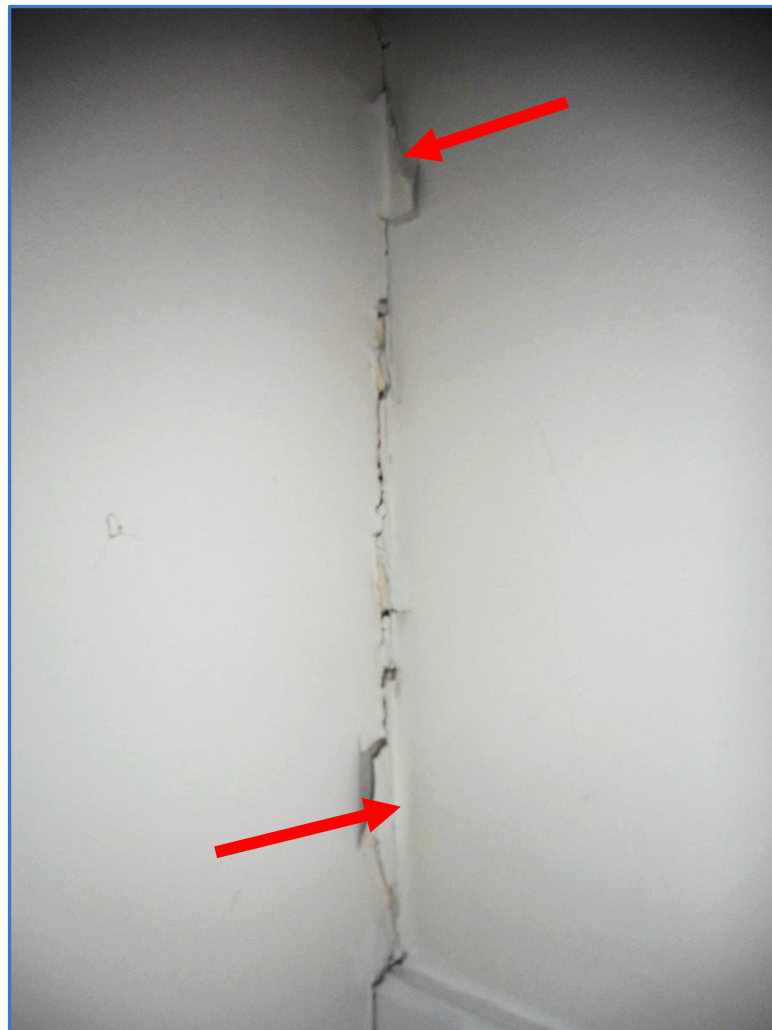
BEDROOM CLOSET WALL TO WALL INTERSECTION SEPARATION

- o Master bedroom wall crack over windows facing the patio.
- o Many wall to wall intersections have been sealed or patched due to shear movement.
- o Middle bedroom closet has significant wall to wall separation.

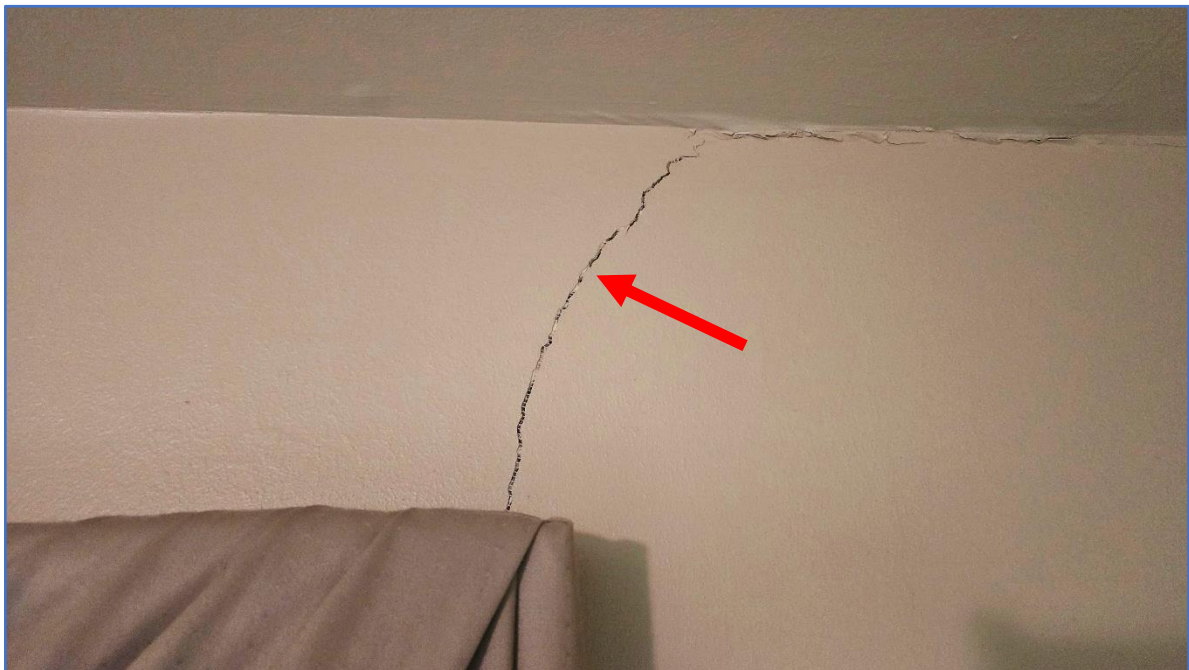
MASTER BEDROOM WALL FRACTURE

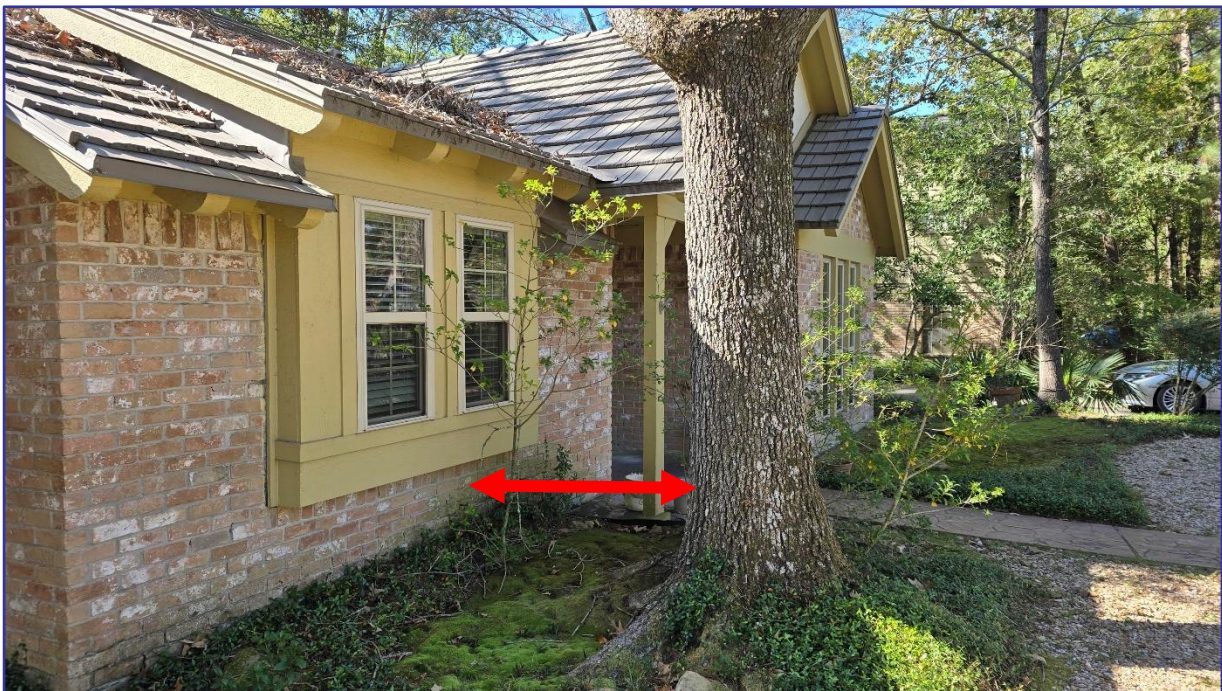
Some of the movement may be attributed to the large tree root system around the house. The tree root systems remove water from the soil causing a drying or shrinking effect. Some movement may be arrested or reversed by proper deep root watering and/or properly installed root barrier systems. **Note that most foundations will not resist the upward forces that may occur when any tree is removed or dies, particularly when expansive soils are present.**

**TREE CLOSE TO FRONT OF HOUSE**

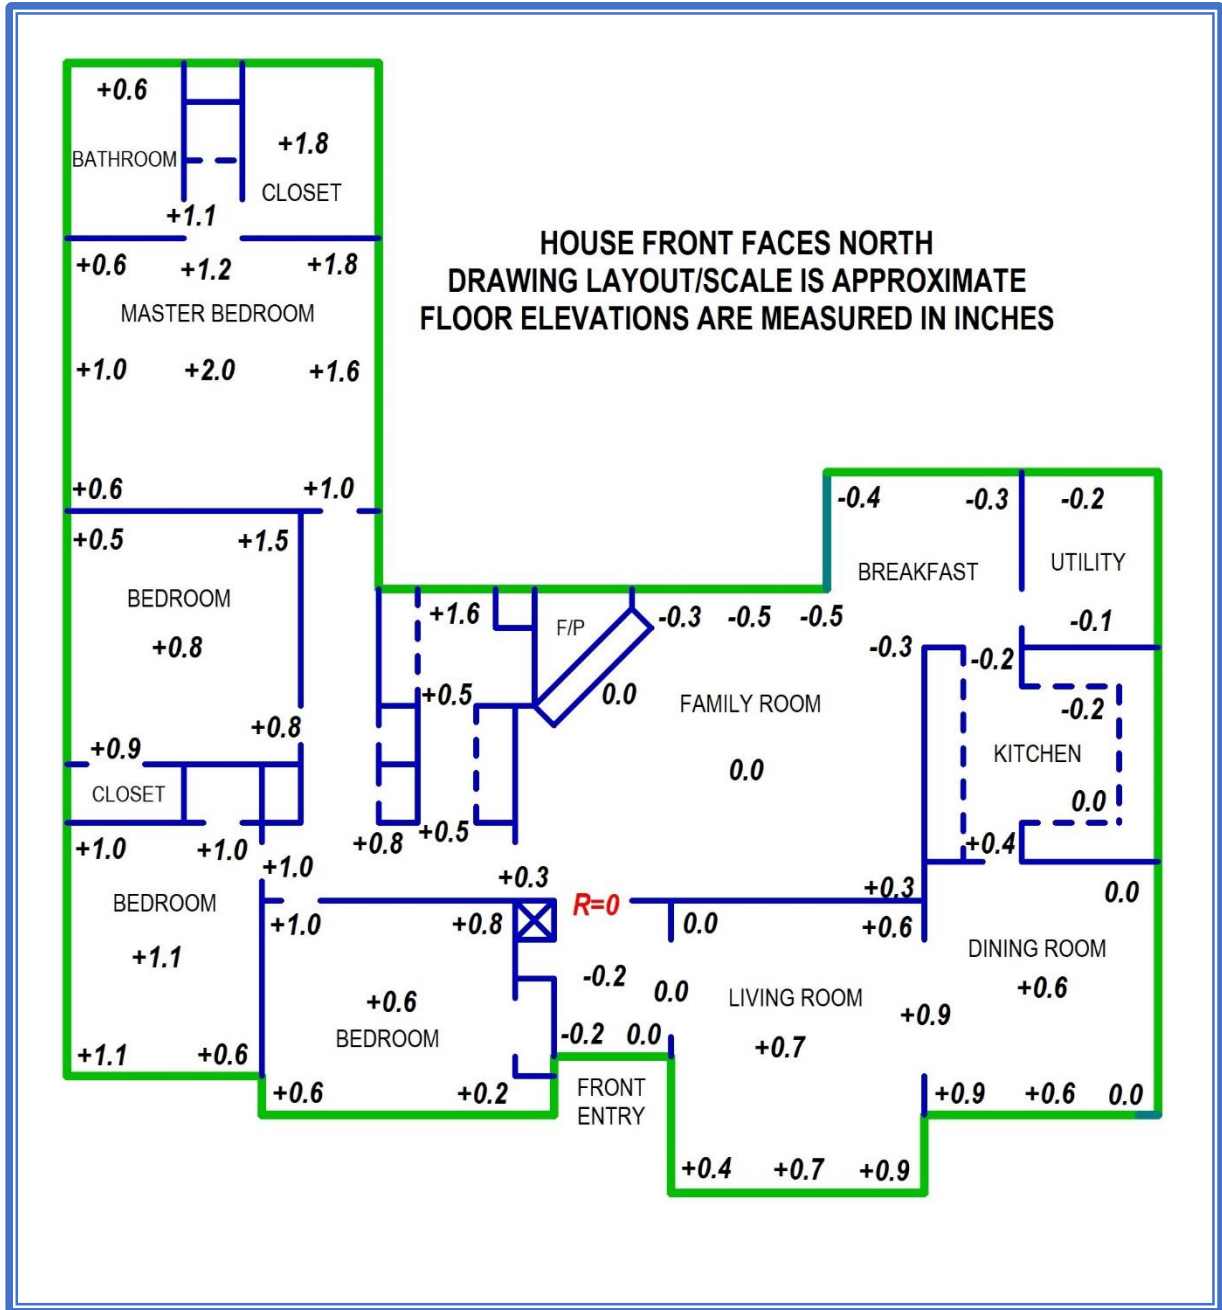
I measured 63 floor elevation locations with the highest elevation at the center of the master bedroom and the lowest at the rear of the family room. The difference across these points is approximately 2.5 inches, which is considered to be moderate movement.
