445 Carolcrest Ln #411  
Livingston, TX 77351

# PROPERTY INSPECTION REPORT FORM

Emily Lombard <i>Name of Client</i>	06/23/2025 2:00 pm <i>Date of Inspection</i>
445 Carolcrest Ln #411, Livingston, TX 77351 <i>Address of Inspected Property</i>	
Jeff Bartee <i>Name of Inspector</i>	TREC #24152, NAWT #16459ITC <i>TREC License #</i>
<i>Name of Sponsor (if applicable)</i>	<i>TREC License #</i>

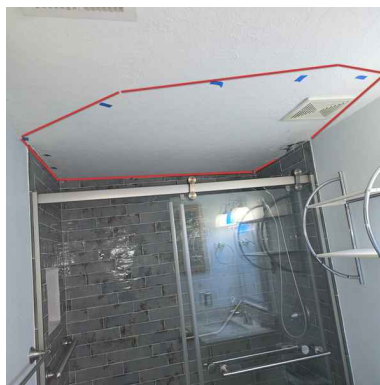
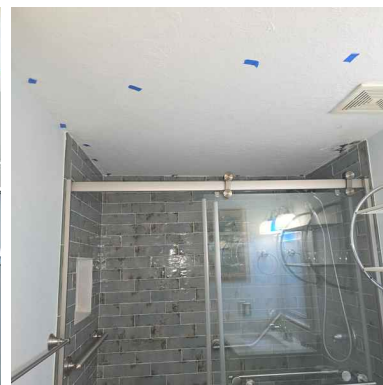
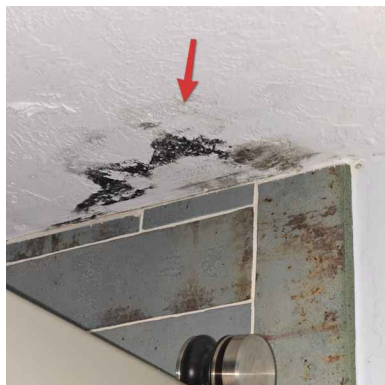
Primary Bathroom - possible microbial growth

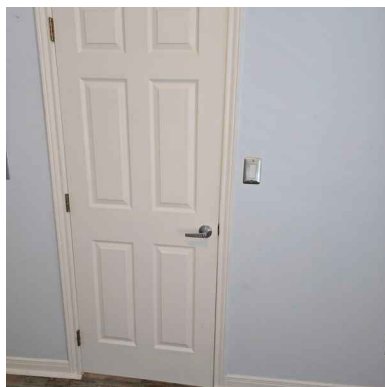
Secondary Bedroom

One or more of the doors in this home drags in the frame and should be adjusted to allow for proper operation.

Recommendation: Contact a qualified handyman.

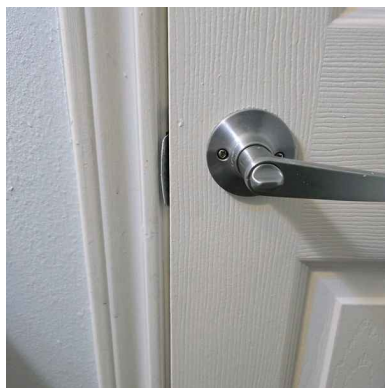
Primary Bathroom

There are one or more striker plates in the door jambs that are in need of repair/adjustments.

Recommendation: Contact a qualified handyman.

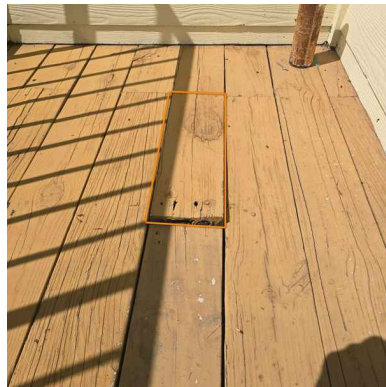
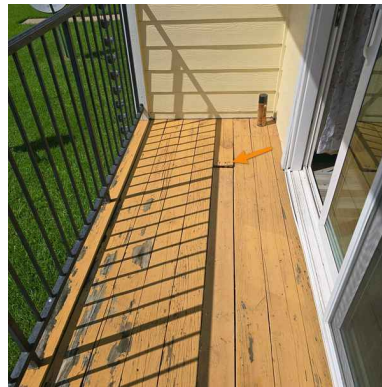
Rear

One of the boards on the rear deck had a deteriorated end and needed that part replaced.

Recommendation: Contact a qualified handyman.

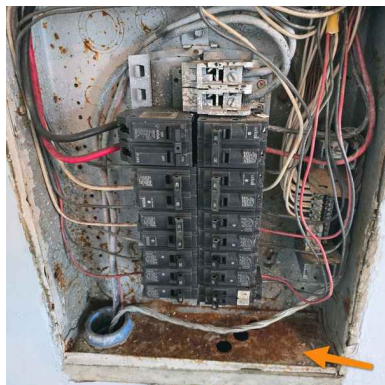
Secondary Bedroom

**1: The electrical panel is rusted**

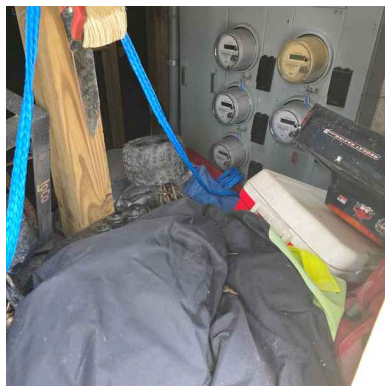
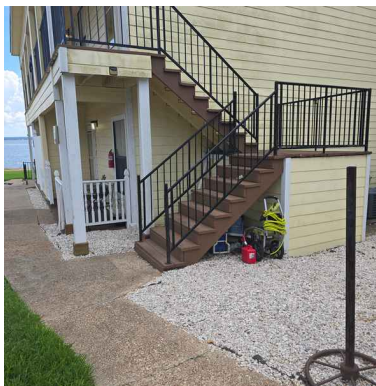
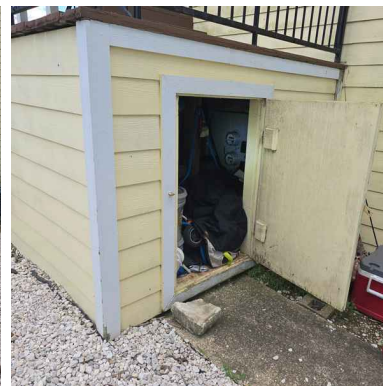
**2: Main Disconnect not Accessible**

There were personal items stored in the area housing the electrical meters and main disconnects for the condos. Recommend personal items be removed as they are blocking access to the emergency disconnects.

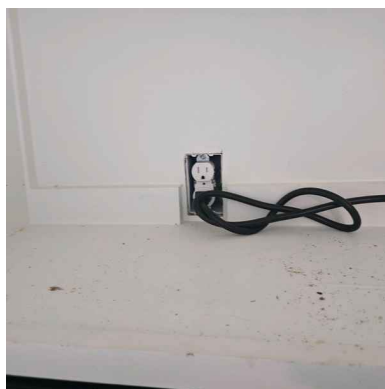
Kitchen cabinet above microwave

One or more receptacle/light switch cover plates are missing and/or damaged. This is a potential short and shock risk. Recommend installation of cover plates as necessary.

Recommendation: Contact a qualified handyman.

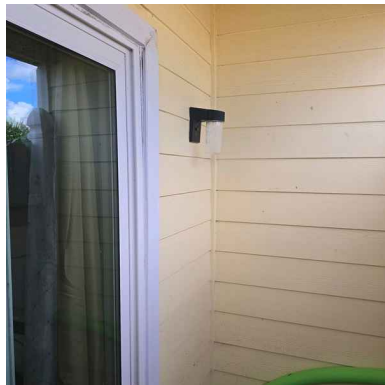
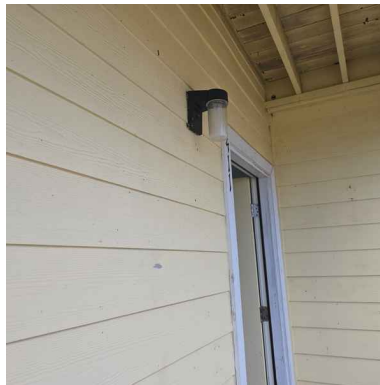
Front patio

Note: All lights that were not operating at the time of the inspection may not be shown. Some of the lights shown may be on dusk till dawn operation.

Recommendation: Contact a qualified handyman.

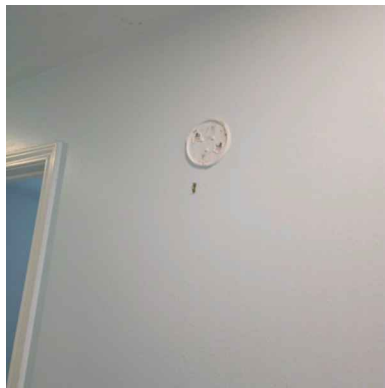
Hallway

There was insufficient smoke/CO alarm coverage at the time of the inspection. Recommend further evaluation and adding missing smoke/CO alarms by a qualified electrical professional.

Recommendation: Contact a qualified professional.

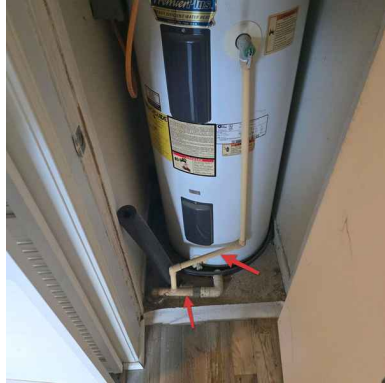
The TPR (Temperature Pressure Relief) drain has other drains discharging into it. The drain must be dedicated exclusively for the TPR valve. Safety hazard. Recommend repair.

Recommendation: Contact a qualified plumbing contractor.
