JAY FISCHMAN, P.E.

RESIDENTIAL FOUNDATION INSPECTION REPORT FOR CHARLES C. WENCK

2214 HIDDEN CREEK DRIVE
KINGWOOD, TX 77339

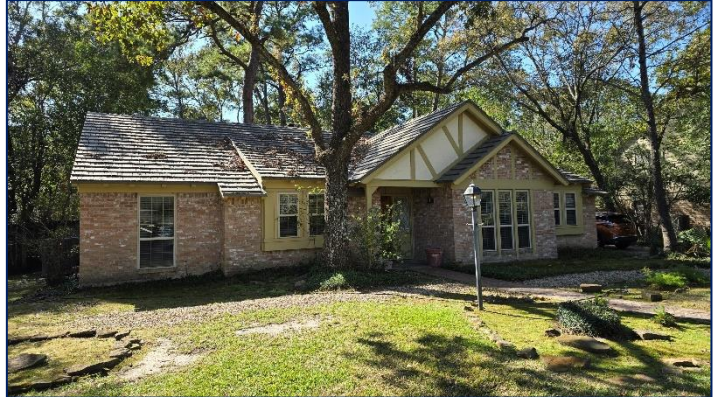
Brick veneer and siding formed the exterior walls. Brick veneer walls provide protection from the elements, provide an intended aesthetic appearance, **but do not support any vertical loads other than the veneered wall itself. The stud wall framing carries the structural loads.**

Most brick masonry units are made from clay or shale, formed while plastic and fired in a kiln. Some are more resistant to water absorption than others. Some molded bricks that are not fired or "burned" at high temperatures and/or burned for short time periods, may absorb some water which can penetrate to the backside of the wall during extended wind driven rainy conditions. Many of these less costly bricks were made in Mexico and are found all over the greater Houston area. Adobe type bricks that are only "sun dried" and other porous bricks, perform better in dry climates. These porous bricks may demonstrate deterioration and/or crumbling in damp and rainy climates as they continue to age. The bricks at this structure appear to be a molded type and were in generally satisfactory condition today. **There were only a few damaged bricks.**

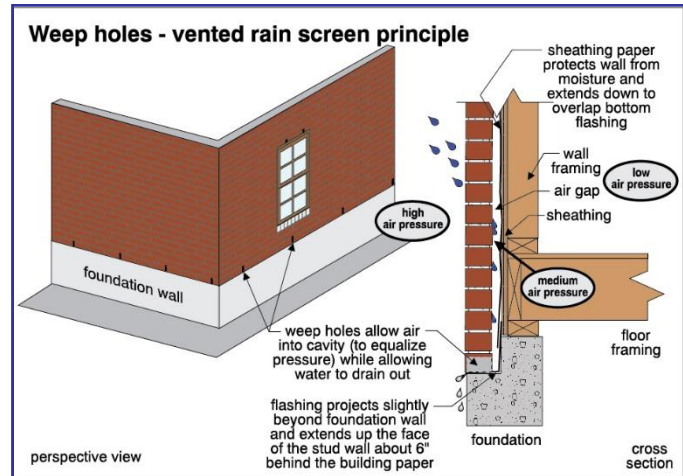
Weep holes are openings placed in mortar joints at the level of any flashing such as window lintels and at the 1st course of bricks in order to permit the escape of moisture. The lack of weep holes above metal window lintels may contribute to lintel corrosion and the lack of weep holes at the 1st course of bricks over the slab brick ledge may contribute to interior water penetration at floor level and wall stains. Mortar droppings behind the veneer wall may restrict air flow and water drainage. Any water penetration within the brick veneer wall becomes a conducive condition for wood destroying insects and interior damage. **Lower level exterior veneer wall weep holes were provided. The presence or condition of any flashing behind the weep holes is unknown to me.**

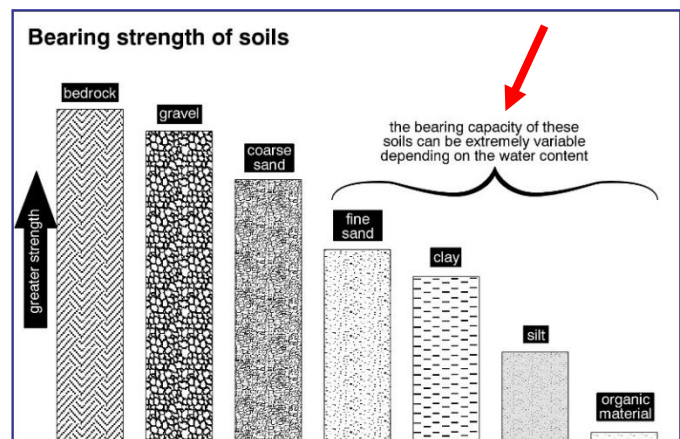
- o Soil movement and inadequate consideration to foundation design to cope with the volumetric changes in the soil supporting the foundation. This particularly applies to foundations cast on expansive clay soils in areas of widely variant soil moisture.
- o Poor workmanship in executing the foundation design.
- o Improper preparation of the site below the foundation prior to the placement of the concrete.
- o A combination or all of the above.
